A STUDY ON FAILURE OF BEAMS IN TERMS OF FORMATION OF CRACKS

This research effort comprises examining beam failure and specifically fracture formation. Two retrofitting methods, wrapping technique and steel jacketing procedures, are employed to repair the cracks. The materials used to cast the beam are selected in compliance with the IS Code. The beam has dimensions of 150mm x 200mm and a span of 1500mm. M25 concrete is used, while Fe415 TMT bars are used for the steel. All beams are tested to the first fracture condition first. The shattered beams received five forms of retrofitting or restoration. For their rehabilitation, a Wrapping Method using GFRP of 225GSM, 400 GSM, 300 CSM, and Jute Fiber was employed. The repaired beams were subsequently put through rigorous testing until they failed. The ultimate load obtained from the experimental test is compared to the theoretical calculation for control Specimen in Limit State Design Method using the clauses supplied in IS 456-2000 code to cross-check the experimental work. The testing results were utilized to compare the Ultimate Load Carrying Capacity and Deflections at that Load for each of the five Retrofitting Methods with the Co

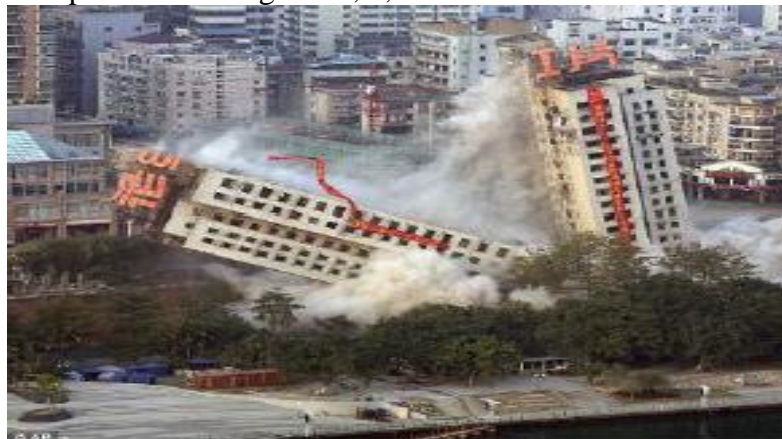
FIGURE 1 SPLITTING OF A TALL STRUCTURE INTO TWO PORTIONS IN A VERTICAL MANNER AT OOGUE AT SIBERIA

continues until this day. Figure 1 depicts a towering building in Oogue, Siberia, being vertically divided into two halves. Another example of structural collapse is the aviation disaster that destroyed the World Trade Center in New York.

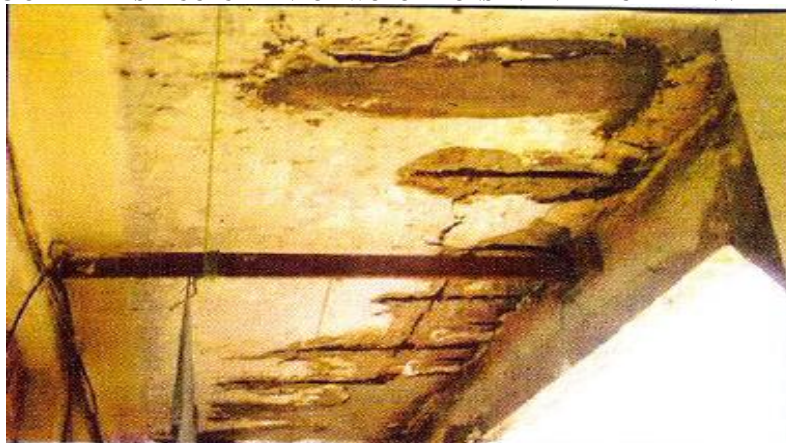
FIGURE 2 CORROSION OF STEEL AND SPALLING OF CONCRETE IN A RCC CANOPY

Speaking about a building's vulnerability to a Civil Engineer is analogous to a patient discussing his or her disease with a doctor. As a result, we must maintain the buildings. Several examples of failures are presented in Figures 2, 3, and 4.

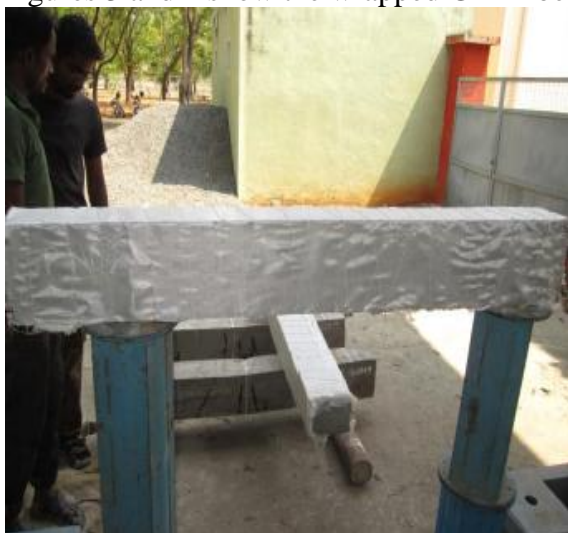
FIG 3 GFRP WRAPPED BEAM - 225GSM

Three beams were loaded till the initial crack for rehabilitation purposes, and the job was completed with GFRP Woven Roving - 225 GSM and polyester resin. The aforementioned work has been wrapped all the way around the beam. The specimen is then left to cure for 24 hours. Figures 3 and 4 show the wrapped GFRP beam and bonded GFRP after resin application.

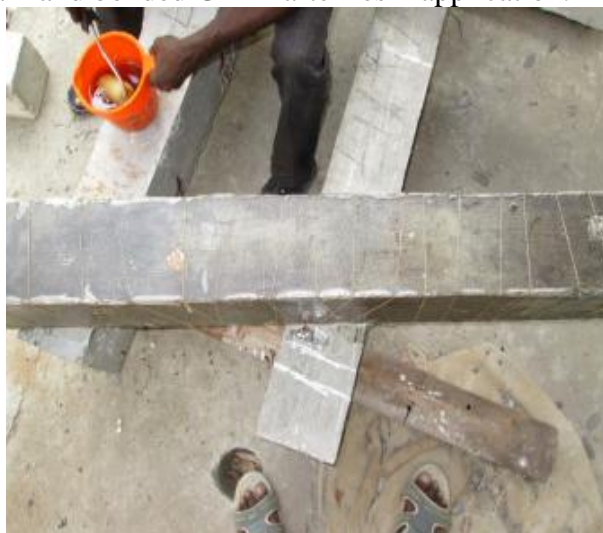
FIG 4 AFTER APPLYING POLYESTER RESIN FOR BONDING – 225 GSM

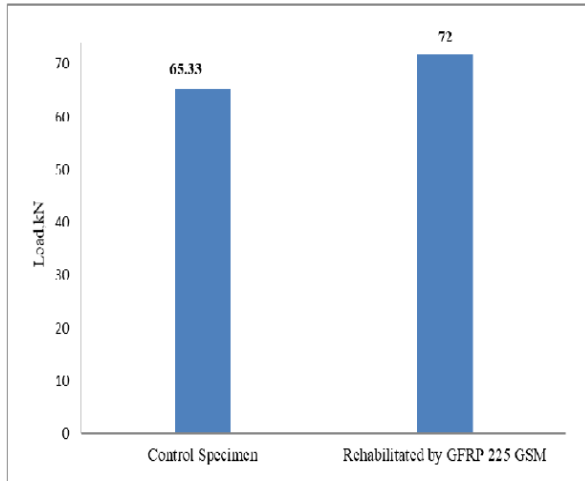
FIG 5 ULTIMATE LOAD

The rehabilitated beam can withstand an ultimate load of 72kN, whereas the control specimen can only withstand 65.33kN. As compared to the control specimen, the ultimate load on the repaired beam has increased by 10.2%. Figures 5 and 6 show a comparison of the beam's ultimate load bearing capability and deflection.

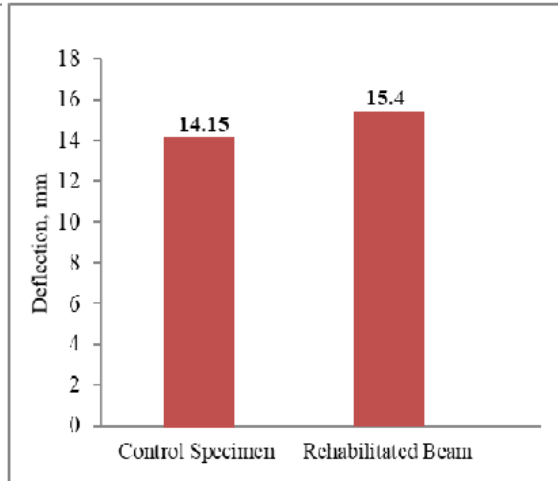
FIG 6 THE DEFLECTION

When comparing the control Specimen to the rehabilitated beam, the deflection increases by just 1.27 mm. When comparing the deflection in percentage, the rehabilitated beam has 9% more deflection than the control Specimen, while the final load bearing capacity increases by 10.2%. Figure 7 depicts the Load versus Deflection graph for the rehabilitation beam for technique 1 beam.

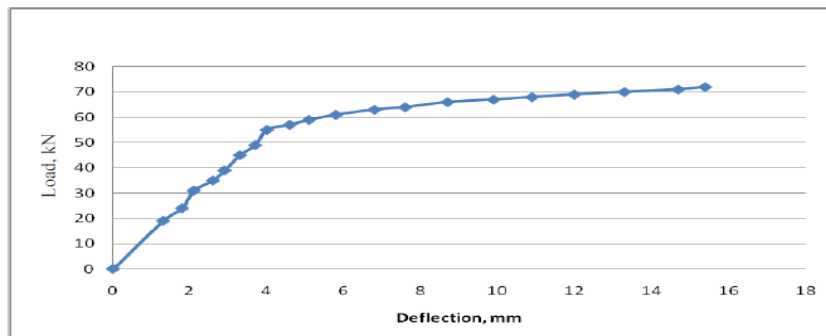
FIGURE 7 LOAD VS DEFLECTION CURVE – REHABILITATED BY GFRP WOVEN ROVING 225GSM

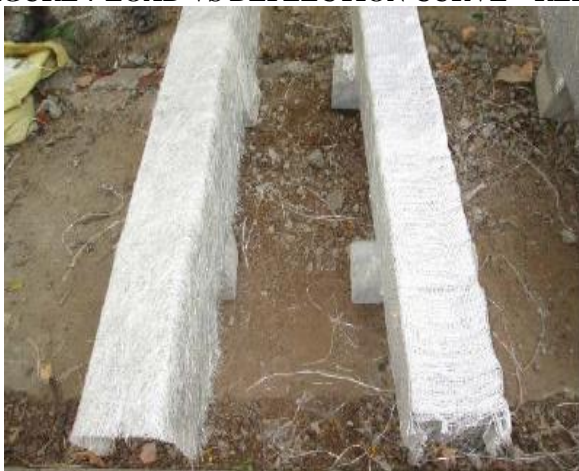
FIG 8 GFRP WRAPPED BEAM

To rehabilitate the beam, first load it until the initial fracture emerges; after the initial crack appears, the loading is halted and the beam is rehabilitated. Following the emergence of the initial cracking load, the loading was halted and the beam was rehabilitated using Glass fiber reinforced polymer, which is E-Class glass fiber with 400 GSM. The glass fiber is completely wrapped around the beam member. As shown in Figures 8 and 9, the GFRP is bonded with the Polyester resin and left for 24 hours to cure or harden.

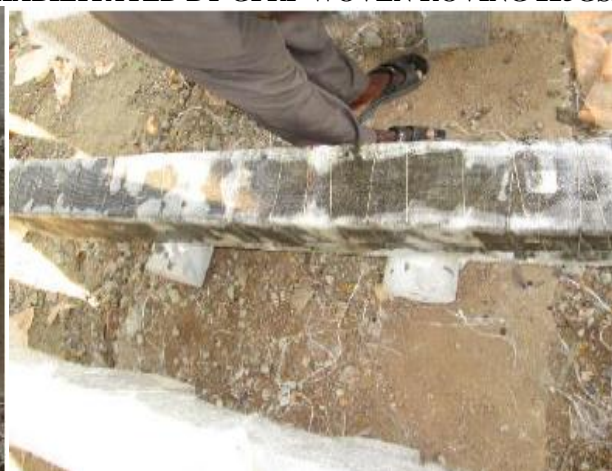
FIG 9AFTER APPLYING RESIN FOR BONDING

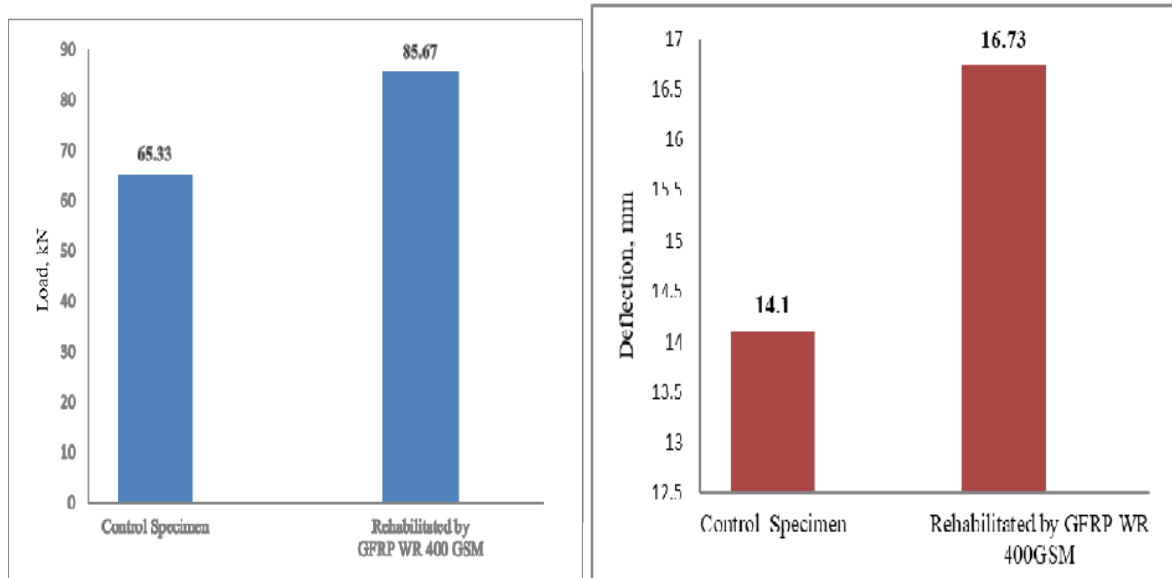
FIG 10 THE ULTIMATE LOAD FIG 11 DEFLECTION FOR REHABILITATED BEAM

The restored beam's mean ultimate load is 85.67kN. When compared to the controlled beam, the ultimate load bearing capacity of the beam is raised by 20.33Kn, or 31% more than the control specimen. Figures 10 and 11 show a comparison of ultimate load bearing capacity and beam deflection for control specimen and repaired beam.

When the deflection for both beams is compared, the restored beam has a deflection of 16.73mm, which is 2.63mm more than the control Specimen. As a result, the repaired beam deflects 18% more than the control specimen and bears 31% more weight. The Load versus Deflection graph for the restored beam is shown in Figure 12.

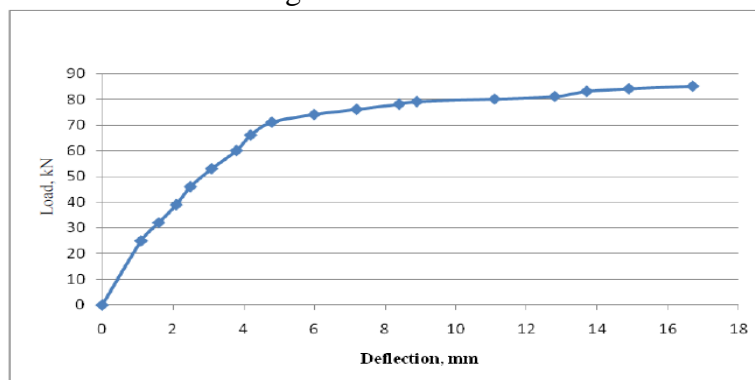
FIGURE 12 LOAD VS DEFLECTION CURVE – REHABILITATED BY GFRP WOVEN ROVING 400GSM

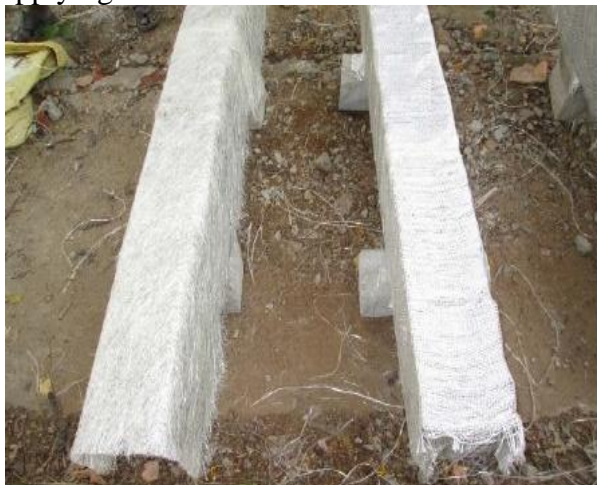
FIG 13 GFRP CSM 300 GSM WRAPPED BEAM

For rehabilitation, the beam is loaded until the first break emerges. The loading was stopped and the weight was removed when the first crack appeared in the beam. After the discovery of first cracking, the beam is rehabilitated using E-Class Glass Fiber Reinforced Polymer, chopped strand mat 300 GSM. Figures 13 and 14 depict GFRP CSM 300 GSM. Beam wrapped before and after applying resin.

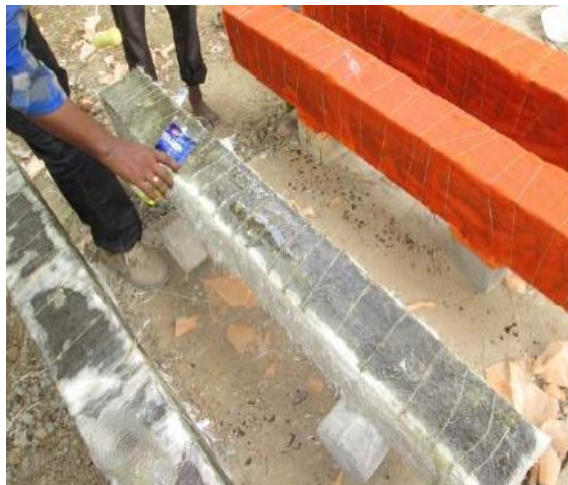
FIG 14 AFTER APPLYING RESIN FOR BONDING

The GFRP is wrapped first, and then polyester resin is put over it. The rehabilitated beam is then left for 24 hours to cure or harden. After curing, the beam is evaluated for its final weight bearing capabilities. Table 4 summarizes the test outcomes.

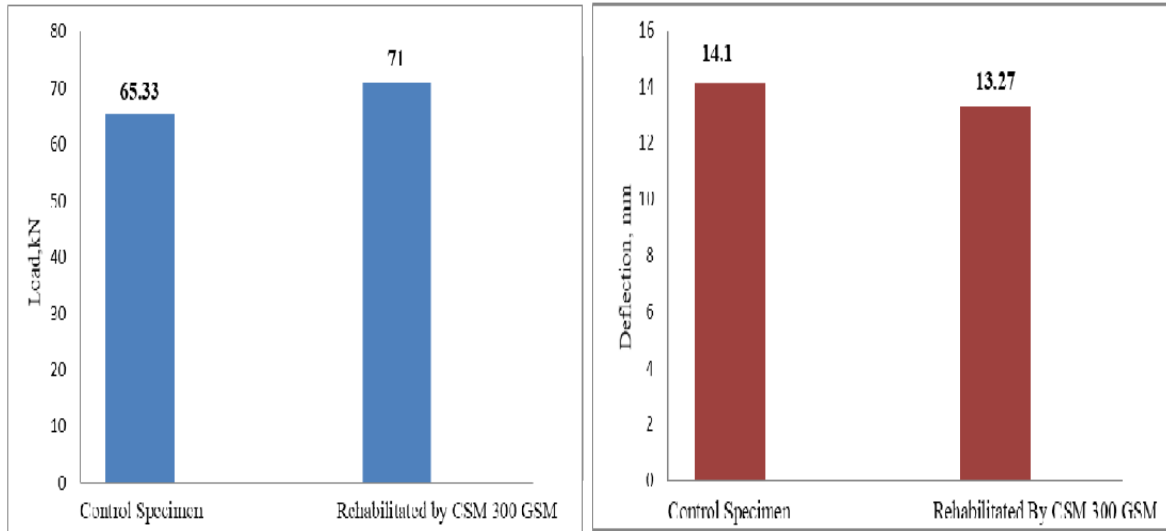
FIG 15 ULTIMATE LOAD

The restored have an average ultimate load of 71kN. The control Specimen's ultimate load value is 65.33kN. This comparison revealed that the beam's ultimate load bearing capability has improved by 5.67kN. As a result, the repaired beam can withstand 9% greater load than the control specimen. The ultimate load and deflection of the beam for the control Specimen and rehabilitated beam are compared as a consequence, and the comparison is depicted in Figures 15 and 16.

When the deflection of the controlled beam is compared to that of the rehabilitated beam, the deflection of the rehabilitated beam is decreased. The controlled beam deflects 14.1mm, but the rehabilitated beam deflects just 13.27mm, resulting in a 0.83mm reduction in deflection. Figure 17 depicts a load vs. deflection graph.

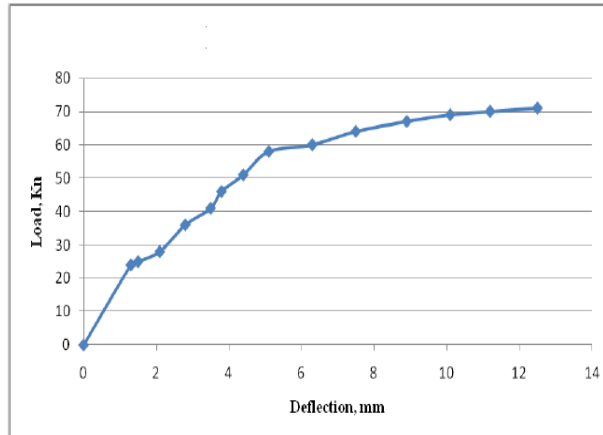
FIGURE17 LOAD VS DEFLECTION CURVE – REHABILITATED BY GFRP CHOPPED STRAND MAT – 300 GSM

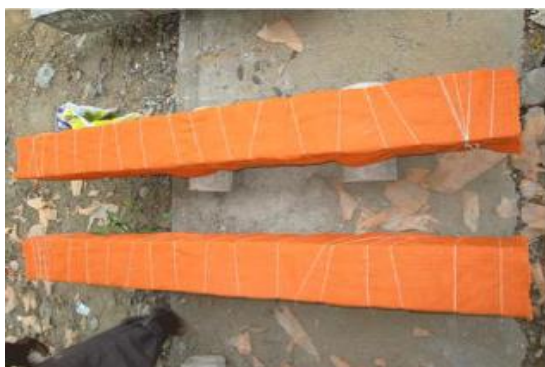
FIG 16 BEAM WRAPPED WITH JUTE FIBER

The beam is tested for rehabilitation by applying a weight until the first crack emerges in the beam. The loading is halted and the imposed weight is withdrawn when the first crack shows in the beam. The restoration is then completed using jute fiber. Polyester resin is used for bonding. After application, the beam is left for 24 hours to cure or harden. Figures 18 and 19 show a beam wrapped in Jute Fiber before and after resin application.

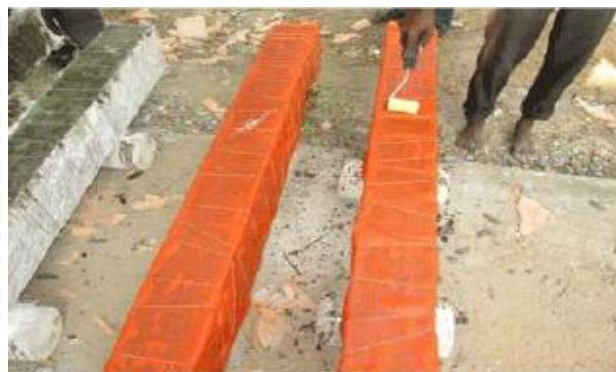
FIG19AFTER APPLYING RESIN FOR BONDING

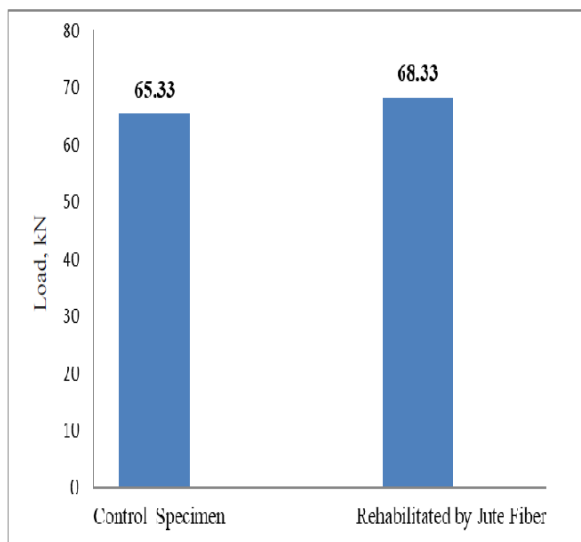
FIG 20 ULTIMATE LOAD

As compared to the ultimate load of the controlled beam, the value of the repaired beam increases as predicted. The improved load bearing capability is 3kN greater than the control specimen; this number appears to indicate that the load increment is substantially smaller. Because the ultimate load is just 5% more than the regulated beam. Nevertheless, the deflection is smaller than that of the controlled beam; the deflection discovered in the control specimen is 14.1mm, while the deflection observed in the rehabilitated beam is only 12.43mm, 1.67mm less than that of the controlled beam. As compared to the control specimen, the restored beam's deflection is reduced by 14%. The ultimate load and deflection of the beam are compared to a control specimen and a repaired beam. And the contrast is depicted in Figures 20 and 4.21.

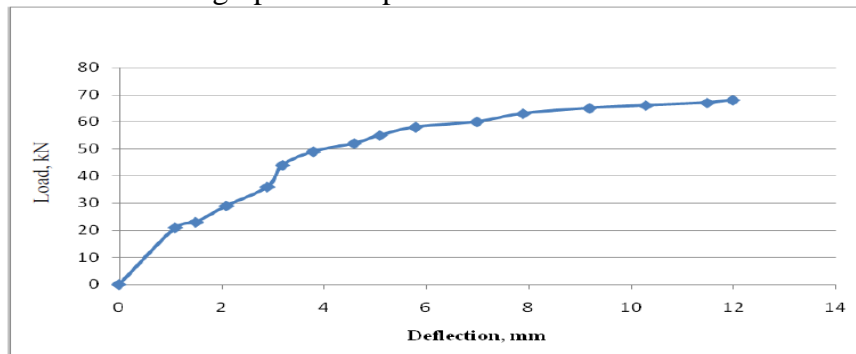
FIGURE 22 LOAD VS DEFLECTION CURVE – REHABILITATED BY JUTE FIBER REHABILITATION

And Load Vs Deflection graph is also plotted for the rehabilitated beam in the Figure 22.

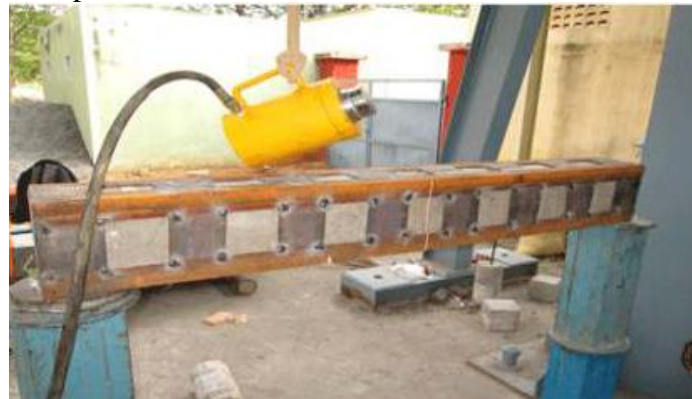
Like with all previous treatments, the beam is initially evaluated for cracking load before being repaired. Figure 23 depicts the construction of a Steel Jacketed Beam in a Loading Frame.

FIGURE 4.22 STEEL JACKETING BEAM

Loading was stopped when the initial crack appeared, and the beam was repaired with steel. Steel is utilized for jacketing in this procedure. The beam is evaluated for its ultimate load after restoration. Table 6 shows the values of the test results.

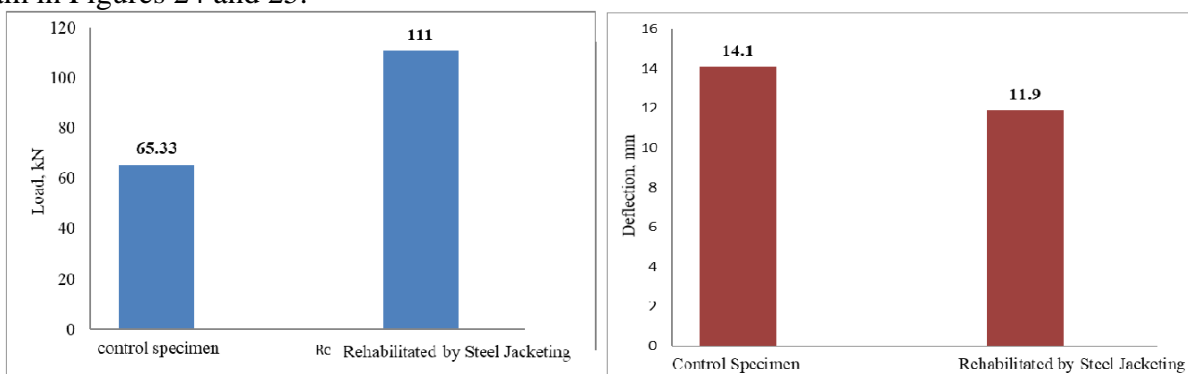
The ultimate load of the restored beam is determined to be 111kN. The controlled beam's ultimate load bearing capability is just 65.33kN. When the ultimate load of the rehabilitated beam is compared to the controlled beam, the load bearing capability of the rehabilitated beam is 44.67Kn. As a result, the load bearing capacity of the load is raised by 70% above the regulated beam. The ultimate load and deflection of the beam are compared with the controlled beam to the restored beam in Figures 24 and 25.

FIG 24 ULTIMATE LOAD 25 COMPARISON OF THE DEFLECTION FOR REHABILITATED BEAM WITH CONTROL SPECIMEN

The control Specimen has a deflection of 14.1mm, whereas the rehabilitated beam has a deflection of 11.9mm, which is less than the control Specimen. The deflection in the restored beam is 2.2mm, which is 16% less than the control specimen.

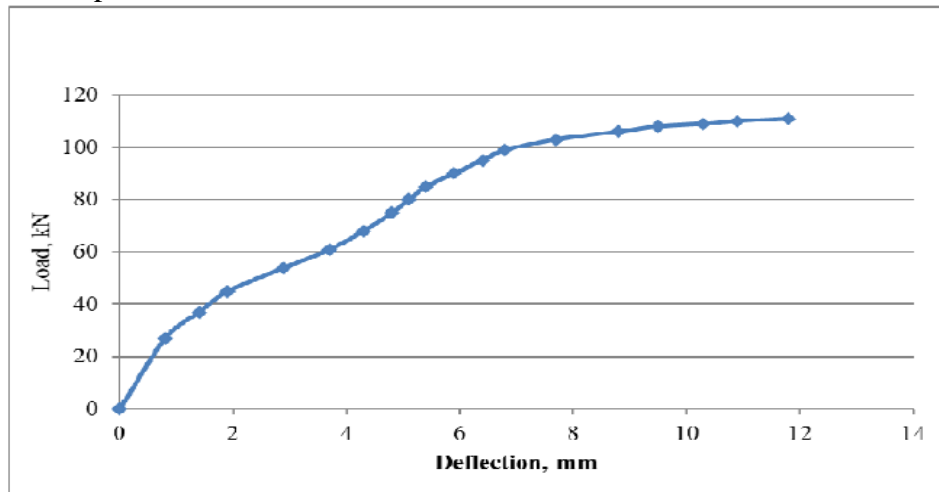
FIGURE 26 LOAD VS DEFLECTION CURVE – REHABILITATED BY STEEL JACKETING METHOD

Figure 26 depicts the load versus deflection curve for the restored beam.
